RE: Groin Mitigation Recommendations [CSE 2416]

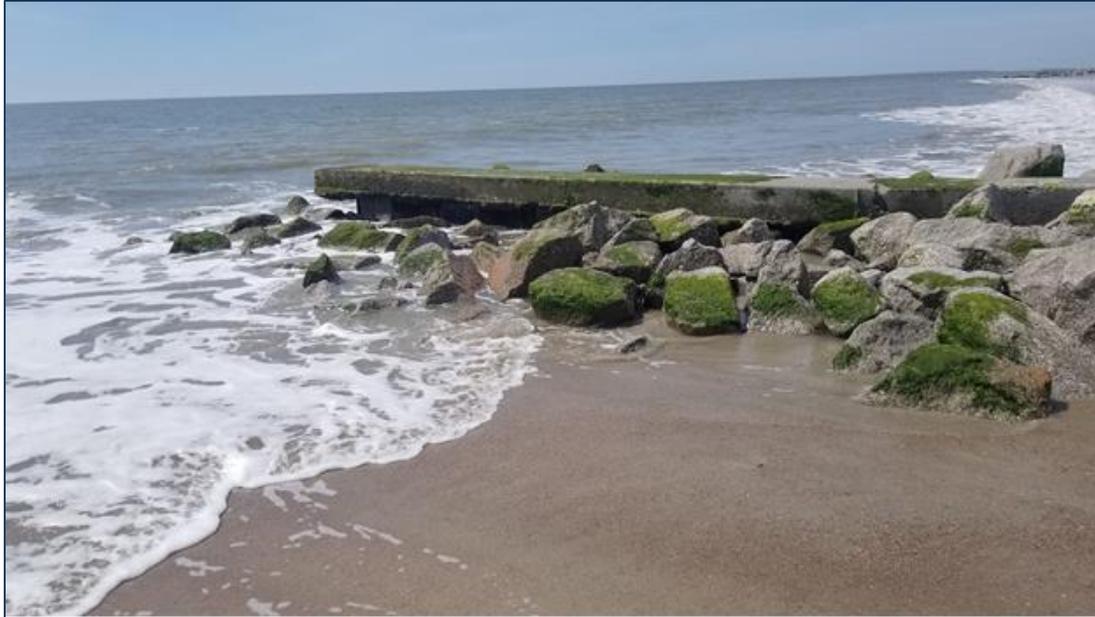
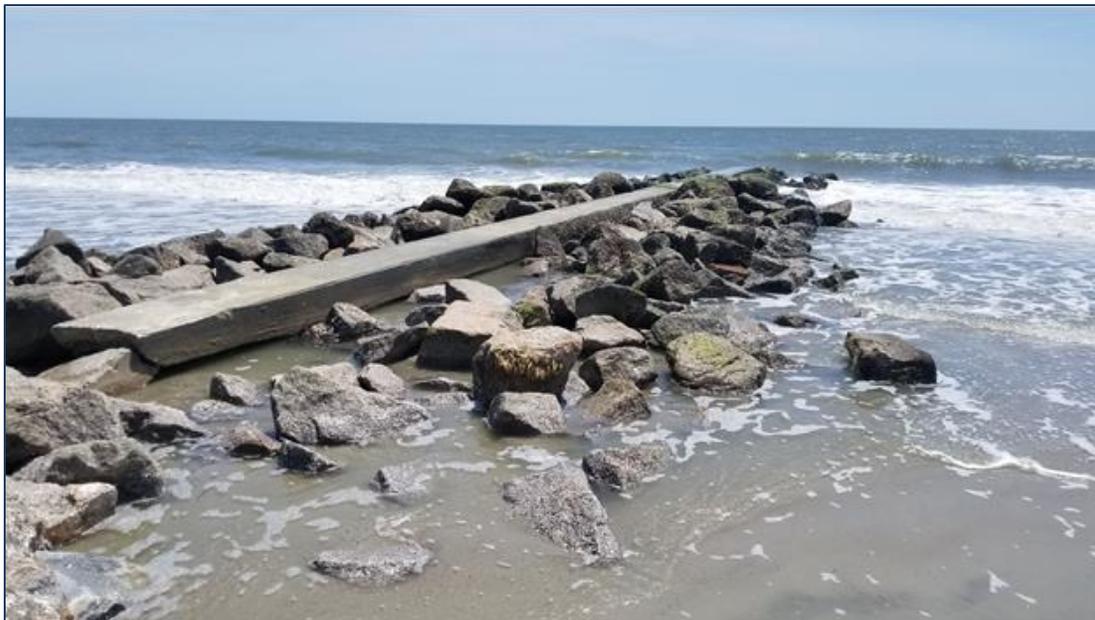
This letter is written to provide CSE's opinion on potential FEMA-sponsored mitigation of future damage via improvements to certain groin extensions. FEMA representatives have indicated that the Town may be eligible for mitigation funds to reduce the potential for future damage from disasters. Specifically, FEMA is considering improvements to the groin extensions to prevent additional scour or slumping of armor stone along the groins extended by sheetpile in 2017 (groins 1-11, 13, and 14). Several of these extensions suffered slumping of the armor stone during Hurricane Irma in September 2017 (Figure 1). CSE recommended the Town repair the damaged extensions by adding additional armor stone to return the stone profile to the original design. This would require ~500 tons of new stone. Placing new stone will restore the design section of the armor stone scour apron; however, future storms may dislodge the stone and result in additional slumping.

**Figure 1.** Post Irma photos of groin damage. Note the slumped stones below the level of the cap leaving the ends of the structures exposed to wave action.

During construction, grout was added to groin extensions 12, and 15-27 to act as a littoral barrier for sand. Sheet pile acted as this barrier for the other groin extensions. Since damage to the extensions was limited to the ungrouted groins, CSE believes that grouting the armorstone may be an effective mitigation alternative to reduce the potential for future damages. Grout solidifies the structures and reduces the opportunity for displacement by waves.

Adding grout to the presently ungrouted extensions would require a contractor placing concrete along the armor stone apron during spring-low tides. Calm weather and waves are also needed to allow time for the concrete to cure before the tide rises. Experience from the 2017 construction project shows that even relatively small waves can quickly wash out concrete before it cures. The cost of grout for the 2017 project was \$650/cy installed. CSE anticipates that unit cost for mitigation work would be similar. CSE estimates that up to 40 cy of grout will need to be added to each groin and a total of 510 cy of grout may required for the complete project. At \$650/cy, the total price for mitigation, not including mobilization or engineering/bidding, is estimated at

\$331,500. In CSE's opinion, mobilization should cost around \$25,000 and engineering/construction admin around \$30,000. The total project cost is estimated to be \$386,500.
