Town of Edisto Beach Local Comprehensive Beach Management Plan

2011 Update

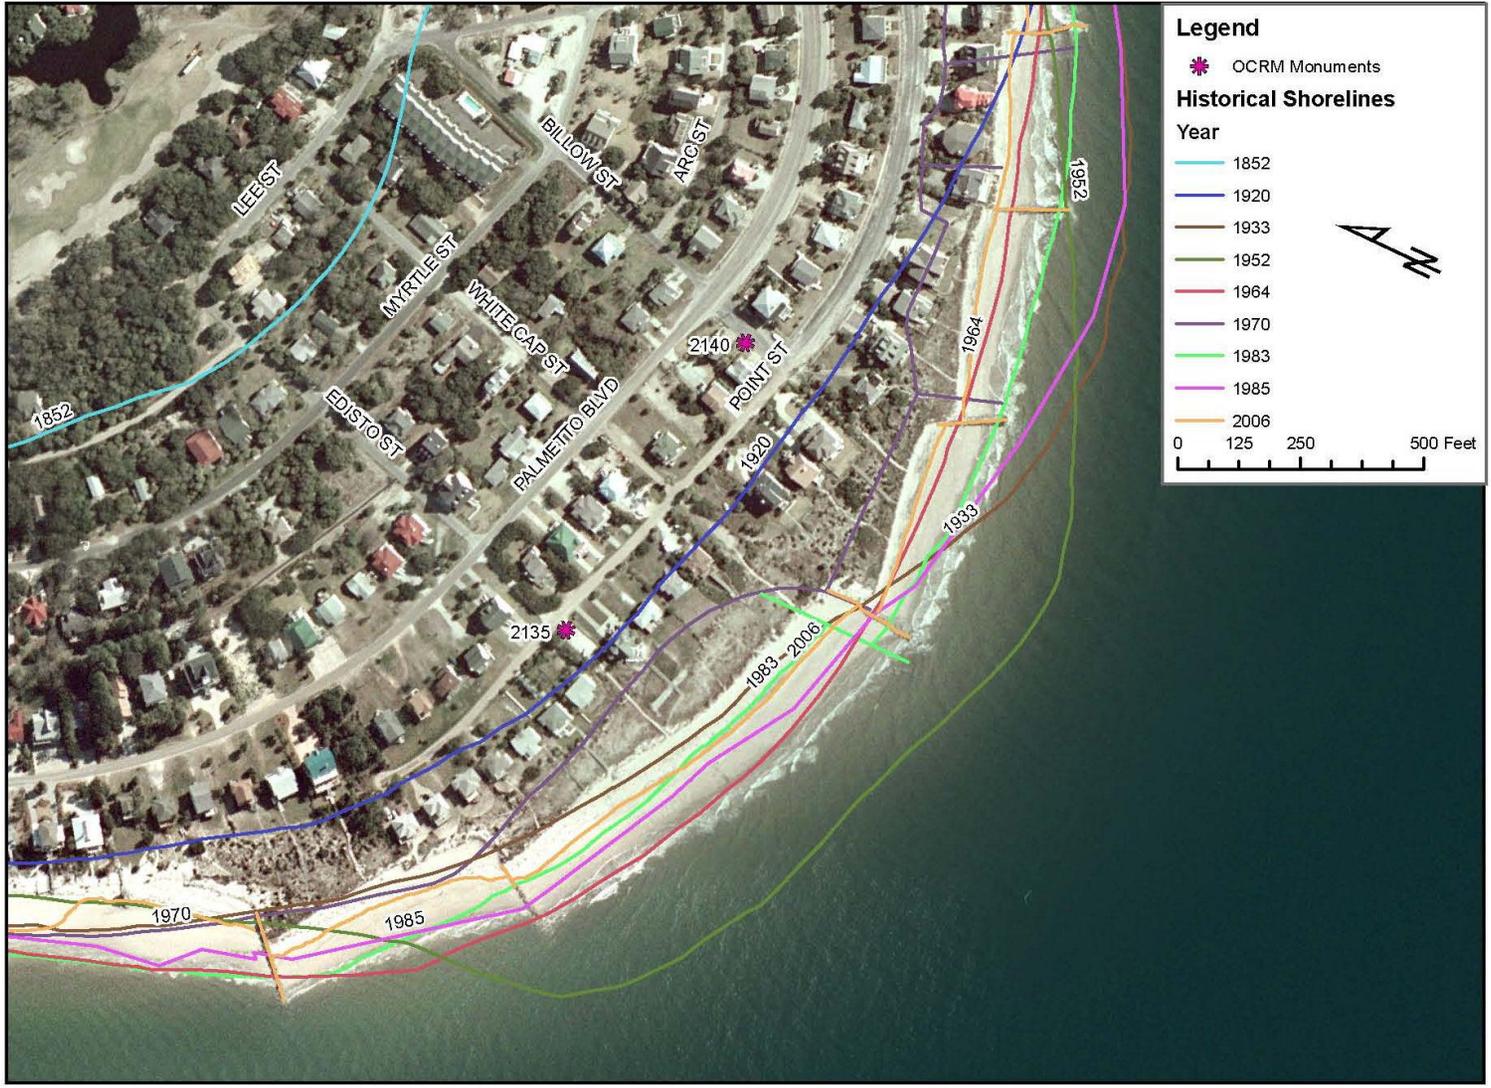
Figure 37. Historical Shorelines near "The Point"

The shoreline position at The Point (Billow, White Cap, and Edisto Streets) is somewhat dynamic, but this area has been accretional in recent years (Figure 37). Since 1852, this section of shoreline has grown seaward by about 1,200 feet.

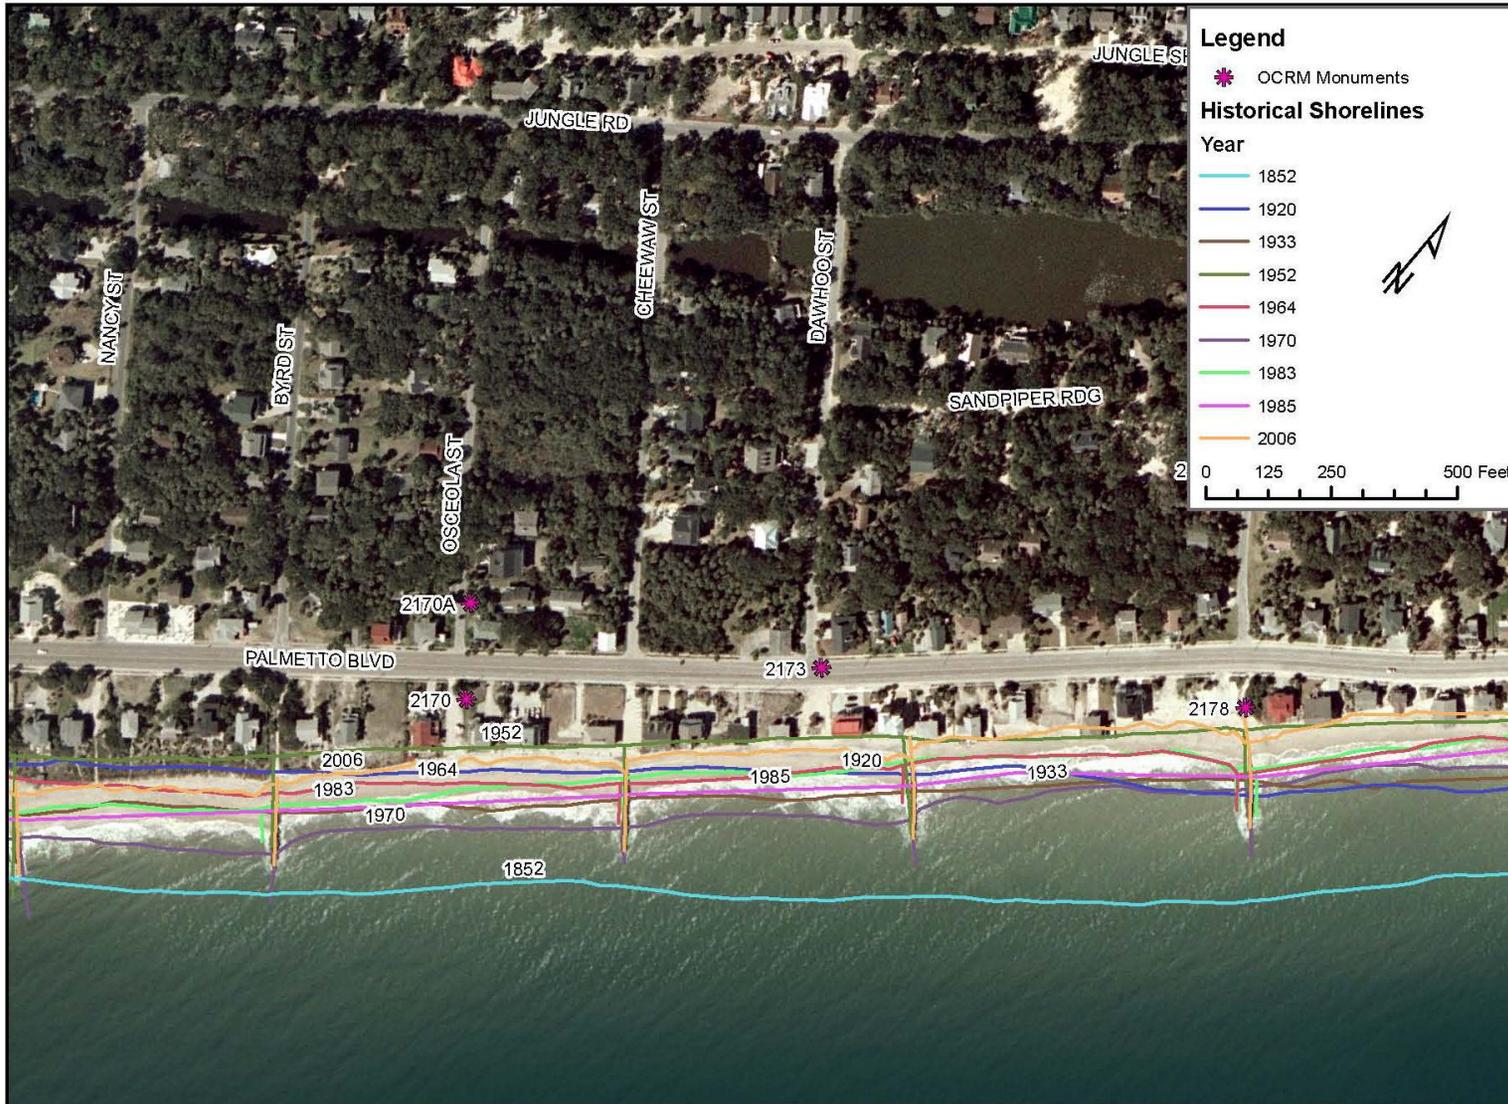
Figure 38. Historical Shorelines in a Standard Beach Zone

In contrast, north of station 2160 in the standard beach zone, groins and renourishment have helped stabilize the shoreline position to some degree, but it is still erosional with a long-term rate of about -2 ft/yr. The shoreline position in this area is now approximately 320 feet further landward than it was in 1852, and many houses are located very near the active beach (Figure 38).

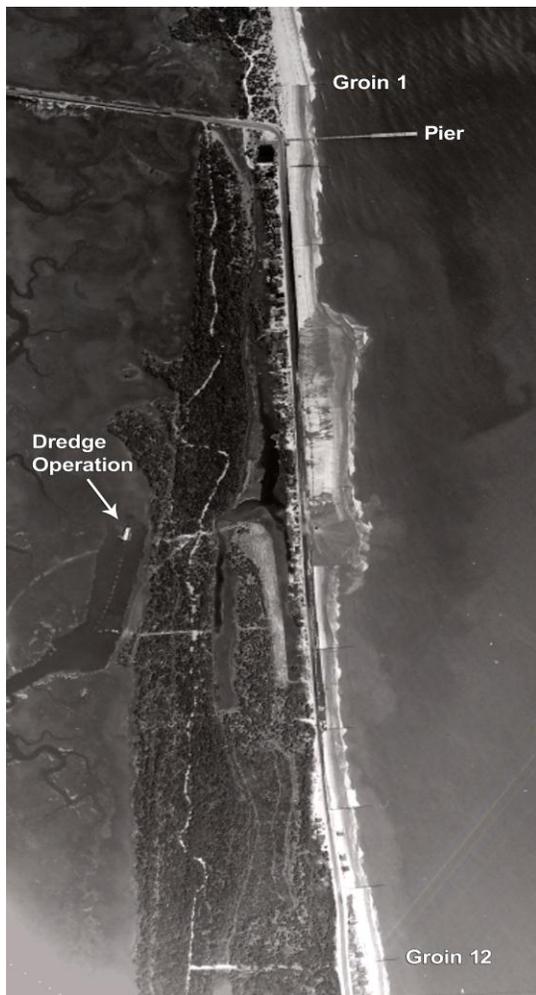
In the mid 1950s, erosion near the Pavilion had progressed so far that groins alone were not sufficient to protect Palmetto Boulevard (SR 174). The South Carolina Highway Department combined groin construction with the first nourishment of Edisto Beach in 1954 using sand, shells, and mud from the marsh behind the island (Figure 41). Excavations created the “Yacht Basin” and reclaimed nearly 1.2 miles of shoreline between Groins 1 and 12. Much of the material was very fine and washed away leaving coarser sand and broken shells.

In April 1995, selected areas of Edisto Beach were renourished (a total of 155,000 cubic yards between Groins 1 to 17 and 24 to 28), and groins (1-16) were repaired (CSE 1996 (a,b), 1997, 1999, 2001). The borrow area was located ~2,500 ft off The Point at the southern tip of Edisto Beach and was characterized by coarse beach-quality sand. By the summer of 2001, roughly one-third of the renourishment volume was still present in the project area.²⁴ Plans called for lengthening of groins 1-10 so that at the seaward end of the groins formed a straight line. The cost of construction was approximately \$1,500,000 including groin repairs. The Town received \$1,000,000 from the 93/94 State Supplement budget as provided by an agreement with DHEC. The agreement required a \$500,000 match.

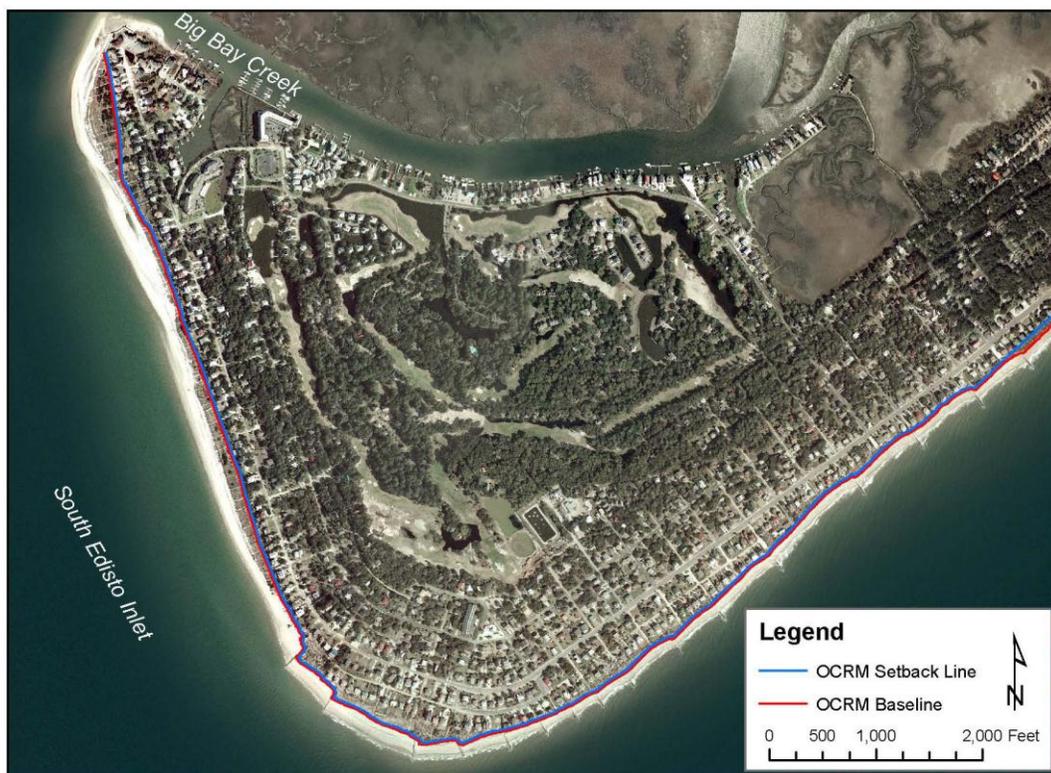
Figure 47. Baseline and Setback Line Map

existed prior to 1988 may be repaired or replaced, if destroyed beyond repair, and if the owner certifies to DHEC OCRM that the pool is moved as far landward as practical, is rebuilt no larger than the destroyed pool, and is constructed in such a manner that cannot become or act as an erosion control device. DHEC OCRM may issue a special permit for all other construction or alterations between the setback line and baseline.
